2006
VOL.7 NO.11

싱글레이션에 의해 발생하는 커패시터 균열의 음파 영상

Acoustic Imaging Of Capacitor Cracks Caused By Singulation

By Tom Adams, consultant, Sonoscan, Inc.

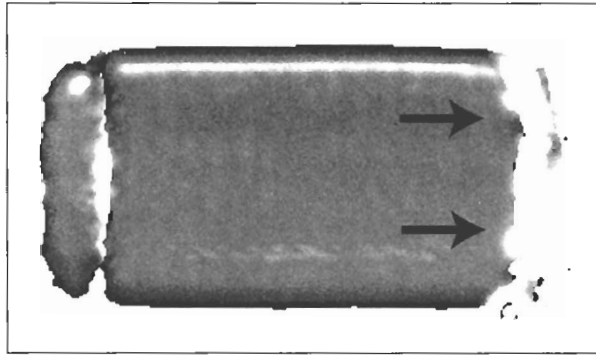
그림 2. Sonoscan 응용 연구소로부터 받은 음파 영상은 수직의 균열
 이 단자와 평행함을 보여준다. 이 전형적인 균열은 싱글레이션
 동안 기판을 파손할 수 있다. 균열은 모든 초음파를 사실상 반
 사하기 때문에 밝은 흰색이다.

마지막 단계로서, 끊어진 패널을 자기장 고장을 일으켰던 기
 판에서 떼어 정확하게 같은 방법을 사용한다. 싱글레이션된 기
 판은 음파 영상을 위해 연구소에 보내졌다. 세라믹 칩 커패시터
 중의 대부분이 현재 내부에 균열을 가지고 있었으며 균열이 거
 의 수직이고 커패시터 단자와 평행되는 근처에 존재했던 것이
 음파 현미경을 통해 드러났다(그림 2). 이제 균열과 자기장 고장
 은 싱글레이션 공정이 진행되는 동안 발생한다는 것을 알았다.
 제조업자는 기판에 대한 기계적 응력을 줄이기 위해 싱글레이션
 공정을 바꾸었다. 그러자 자기장 고장의 근본 원인은 제거되었
 다. 싱글레이션 공정의 수정 후 어셈블리된 기판의 음파 영상은
 커패시터에 어떠한 균열도 일으키지 않음을 밝혀냈다.

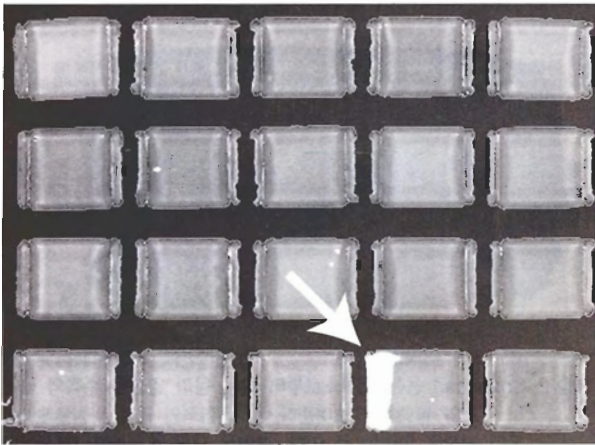
그림 3. 세라믹 칩 커패시터의 트레이 부품은 공급업체로부터 받은 많은 커패시터를 인증하기 위해 어셈블리 전에 음파적으로 영상화되었다. 하나의 커패시터는 큰 내부 균열(화살표)을 가지고 있다. 다른 소수의 커패시터는 작은 내부 보이드(작은 원의 하얀 부분)를 가지고 있다.

그림 3은 품질 조사되었던 세라믹 칩 커패시터의 트레이 부분의 음파 영상이다. 커패시터 중 하나가 큰 균열(밝고 하얀 부분)을 갖고 있는데, 이 균열은 커패시터 끝 부분에 있고 아마 수직의 진행방향을 가진다. 만일 이 균열이 무작위 검사에서 발견되지 않으면, 그것이 PCB의 싱글레이션에 의해 발생한 균열이라는 것을 나중에 쉽게 진단될 수 있다. 表

그러나 어셈블러는 커패시터가 공장에 도착되었을 때 부품을 스크린하는 음파 현미경을 통해 균열된 커패시터의 유입을 막을 수 있다. 몇몇 어셈블러는 공급업체로부터 받은 수많은 커패시터를 인수하기 위해 음파 현미경으로 시험을 한다. 전형적으로 어셈블러는 들어오는 많은 커패시터의 몇 퍼센트를 조사하고, 결과에 따라 그것을 받아들이지 결정한다. 상당히 높은 신뢰성이 필요한 작업물의 경우 다른 경우와 달리 어셈블러가 커패시터의 100%를 조사한다.

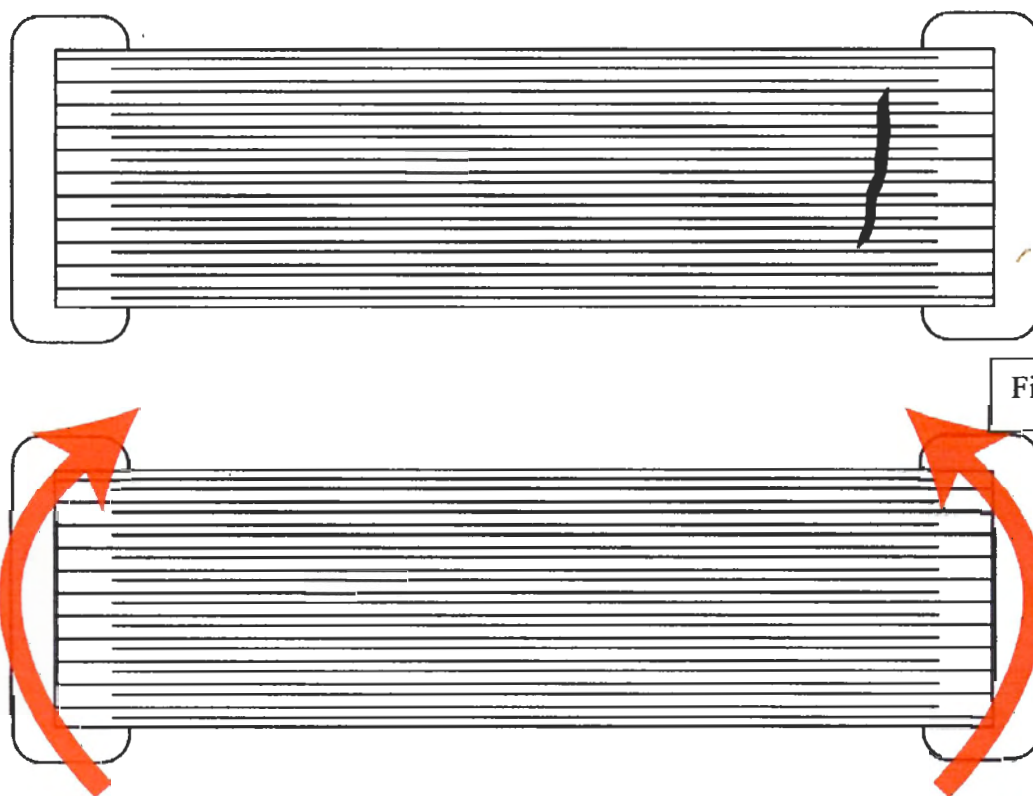
The laboratory technicians knew from long experience that vertical cracks near the terminations are often caused when printed circuit boards are snapped apart (singulated) at the end of assembly. When the boards are snapped apart, each board is bent slightly. The FR4 board is somewhat flexible, but the ceramic chip capacitor is very rigid, and the capacitor is strongly soldered to the board. The mechanical stresses from the bending of the printed circuit board are sometimes relieved by the formation of a crack in the capacitor [Figure 1]. Such a crack is typically vertical, near a termination, and does not always reach the surface of the capacitor, so it cannot be seen optically. Sonoscan's laboratory reported the images, and the interpretation of the images, to the manufacturer of the failed systems.

Figure 1 Flexing of the FR4 board during singulation puts mechanical stress (arrows) on the surface-mounted ceramic chip capacitor. If the stress is large enough, the result may be a vertical crack in the capacitor (top).

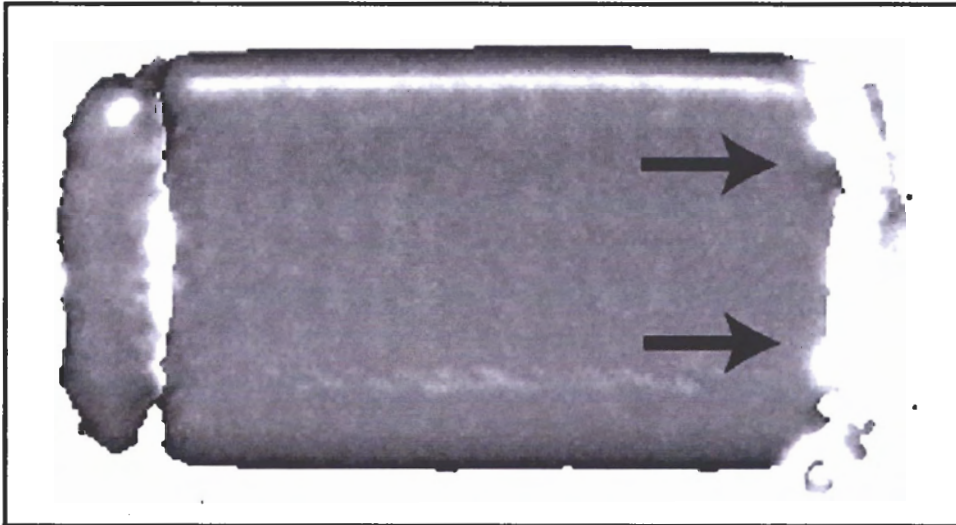
As a final step, the panels were then snapped apart, using exactly the same method that had been used to separate the boards that had failed in the field. The singulated boards were then sent to the laboratory for acoustic imaging. The acoustic microscope revealed that many of the ceramic chip capacitors now had internal cracks, that the cracks were nearly all vertical, and that the cracks were near the capacitor terminations and parallel to the terminations [Figure 2]. It was now clear that the cracks, and the field failures, were being caused by the singulation process. The manufacturer changed the singulation process in order to reduce the mechanical stress on the boards, and the root cause of the field failures was eliminated. Acoustic imaging of boards assembled after the modification of the singulation process revealed no cracks in the capacitors.

Figure 2 Acoustic image from Sonoscan applications laboratory shows a vertical crack parallel to the termination – typical of cracks that may occur when boards are snapped apart during singulation. The crack is bright white because it reflects virtually all of the ultrasound.

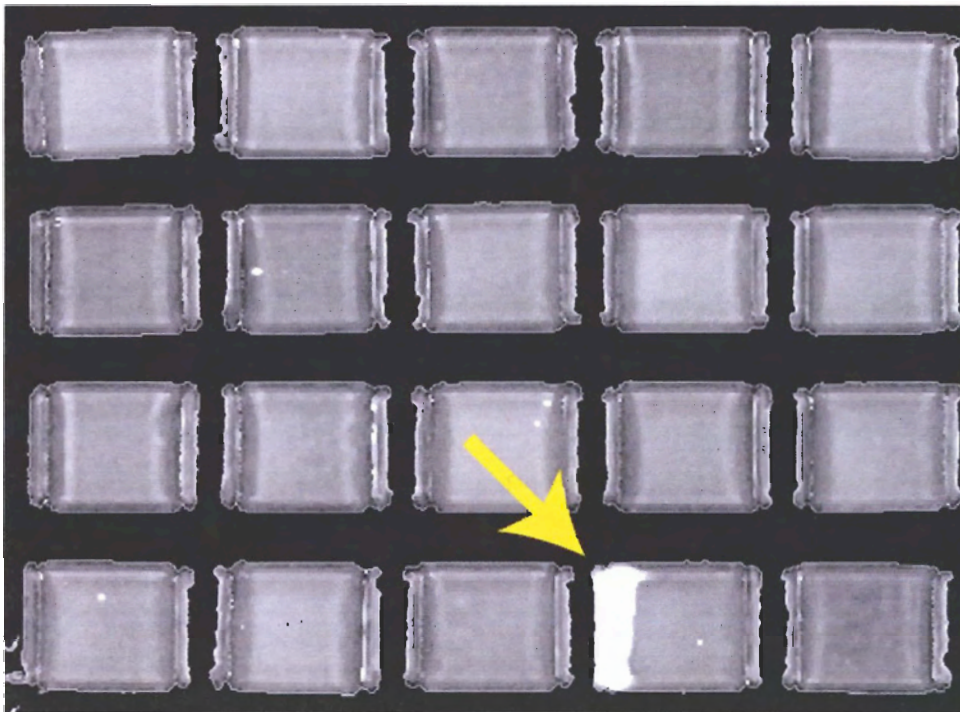
Figure 3 is the acoustic image of a portion of one tray of ceramic chip capacitors that were scanned to qualify an incoming lot. One of the capacitors has a large crack (bright white area); this crack is near the end of the capacitor and probably has a vertical orientation. If this crack were not

discovered in the incoming lot, it could easily be diagnosed later as a crack that had been caused by singulation of the printed circuit boards.

Figure 3 Part of a tray of ceramic chip capacitors imaged acoustically before assembly to qualify the lot of capacitors delivered by the supplier. One capacitor has a large internal crack (arrow). A few other capacitors have small internal voids (small circular white features).

But the assembler can protect himself against the cracks in incoming lots of capacitors by using an acoustic microscope to screen the parts when they arrive at his plant. Some assemblers use acoustic screening as a requirement for accepting the lot of capacitors from the supplier. Typically the assembler scans a percentage of the capacitors in an incoming lot and bases his acceptance on the results. In other cases, and especially where the reliability requirements are high, the assembler may scan 100% of the incoming capacitors.
