# CHARACTERIZATION OF FLIP CHIP BUMP FAILURE MODES USING HIGH FREQUENCY ACOUSTIC MICRO IMAGING

Janet E. Semmens and Lawrence W. Kessler  
SONOSCAN, INC.  
530 East Green Street  
Bensenville, IL 60106 U.S.A.  
Tel: 630 766-7088 Fax: 630 766-4603  
E-mail: sonoscan@WorldNet.att.net

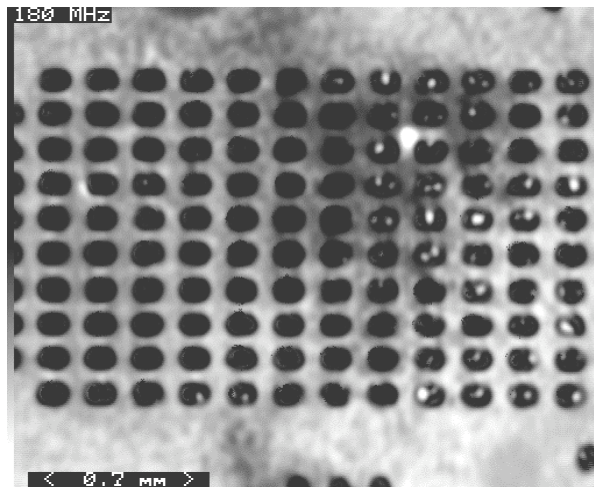
Figure 2 - 180 MHz C-SAM image of flip chip bond Small voids at the interface appear as white features. Bonded bumps appear dark. A void (white area) is also present in the epoxy underfill.

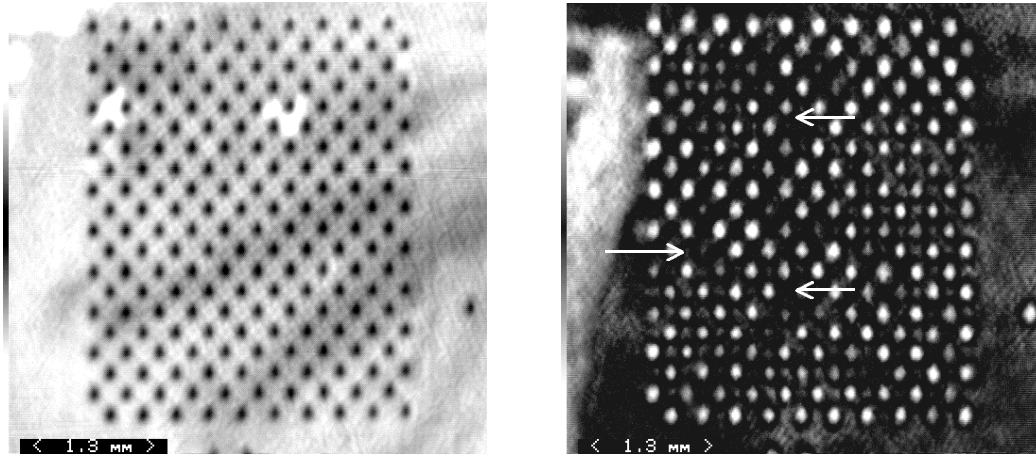
Figure 3 - Compares the acoustic image of the chip to bump level (left) to the bump to substrate level (right) in a flip chip sample. At the chip to bump interface bonded bumps appear dark in the acoustic image. At the bump/substrate level the bump should appear bright if there are no defects present in the image to obstruct the ultrasound from this level. Any defect at a previous level will block the ultrasound from this level causing the bump site to appear darker like the areas indicated by the arrows.

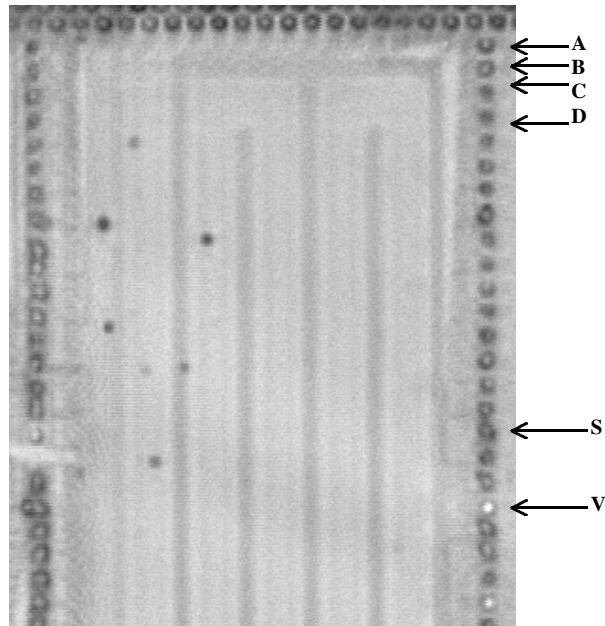
Figure 5 - Acoustic image of the bump to substrate level. At this level defects in the solder bumps above the interface cause dark shadows in the image of the bond site. The bright appearance of several bumps indicates they are the only defect free bumps.

The samples were then subjected to destructive physical analysis and conventional optical microscopy for correlative analysis. At this time the defects were assumed to be cracks and voids in the solder based on previous samples which had not undergone acoustic analysis. Initially the acoustic data did not show good correlation with the DPA results. Bumps which were cracked as seen in the DPA showed defects acoustically. However, many of the solder bumps indicated to be defective acoustically did not appear to have cracks in the solder joints. Figure 6 displays the optical micrographs for several example bumps which are indicated on the acoustic micrograph shown in Figure 5.

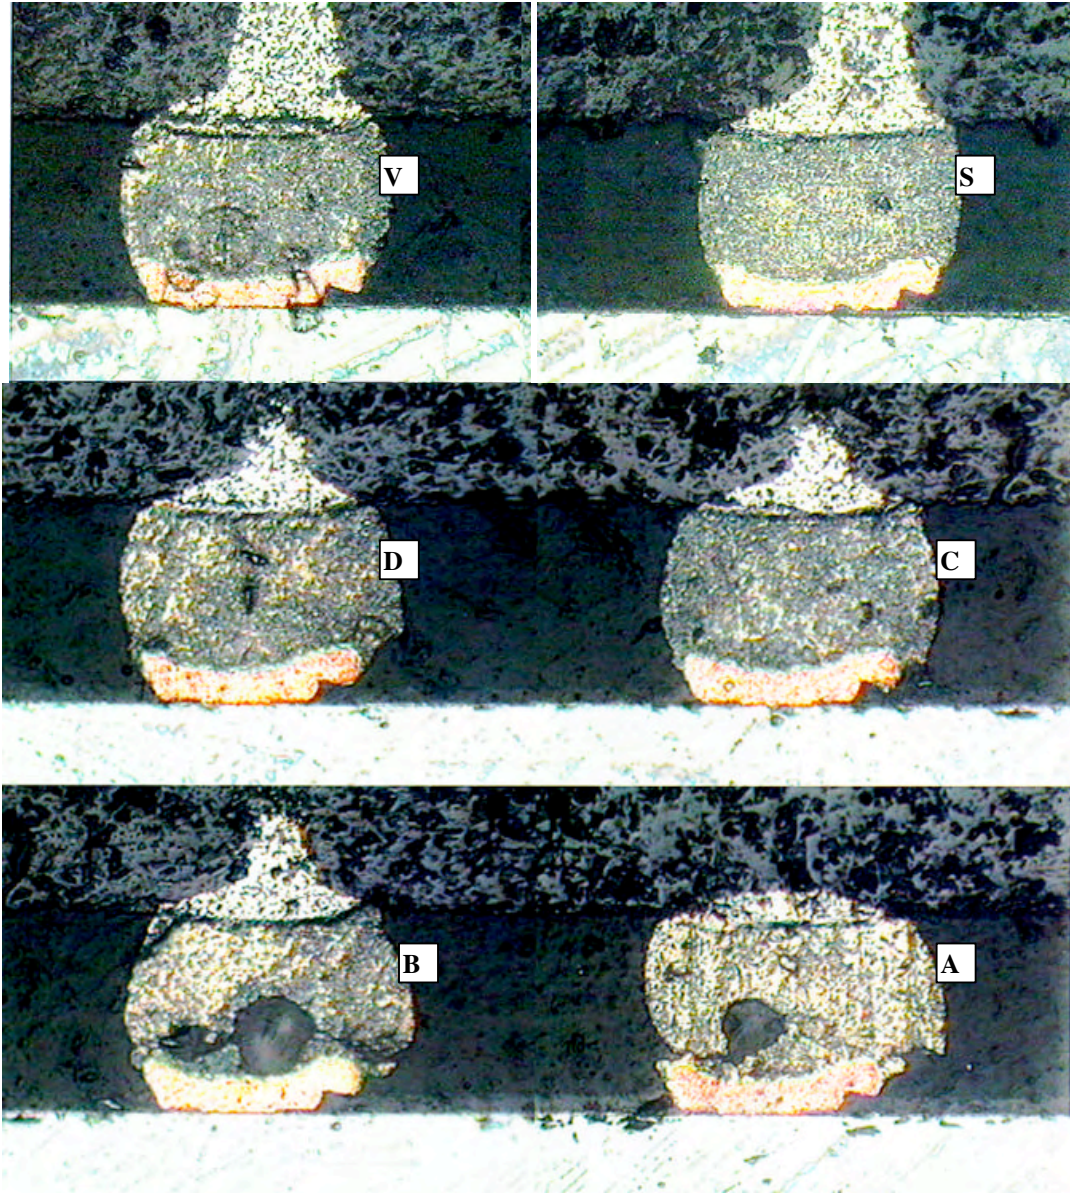
Figure 6 - Optical micrographs of several bumps pointed out in the acoustic micrograph are shown here. Bump V appears bright in the acoustic image indicating no defects above the interface and the optical micrograph also shows no defects within the solder ball. Bump S, however, appears defective acoustically but also shows no defects within the solder ball in the optical micrograph. C and D also appear defective in the acoustic image but do not show voids or cracks in the solder bumps. A and B appear defective according to the acoustic image and display cracks and voids in the solder bumps.

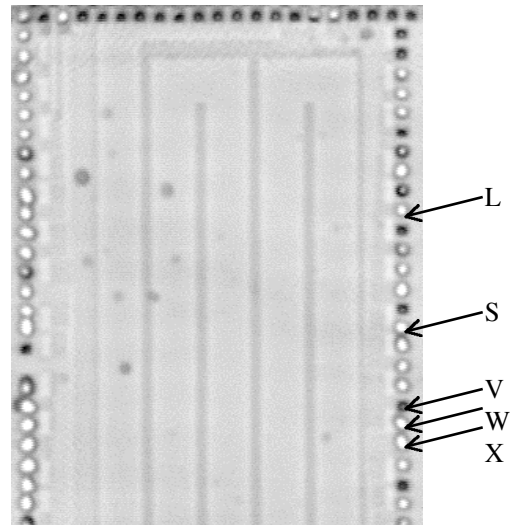
Figure 8 - Acoustic image of chip/bond pad level using level specific imaging technique. Now variations in the signal intensity are apparent from one bond site to another. The strong signal reflections characteristic of voids and delaminations are shown in white. The white bumps also are the ones which display the larger, irregular shapes. Dark spots indicate the bonded pads at this level. Several of the sites are indicated by the arrows for reference in the corresponding DPA images.

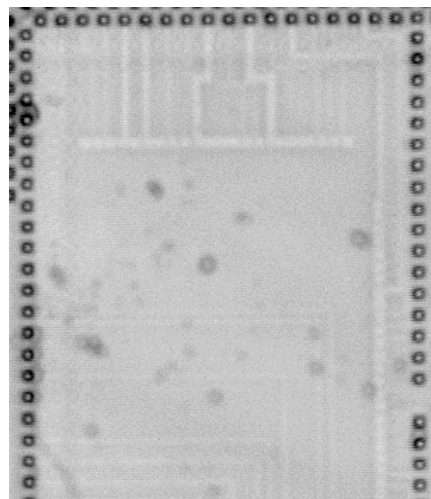
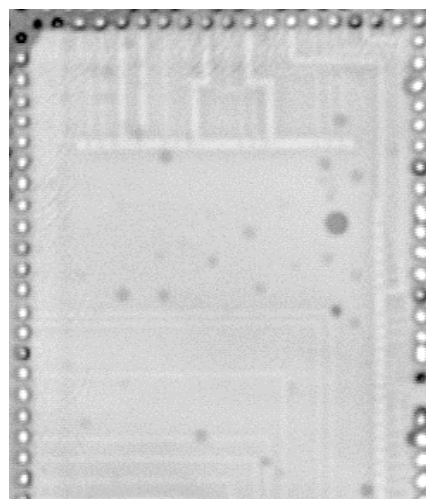
Now the device showed similar defects. Figure 9 compares acoustic images of the same device before and after cycling. Clearly the thermal cycling was inducing defects, and the types of defects being induced by the testing were not just the cracks within the solder balls.

Figure 9 - Acoustic images of the same device before and after thermal stress. The bond sites appear as dark circles, uniform in size before stress. After stress most of the bond sites now appear bright white and some are considerably larger in size and irregularly shaped.

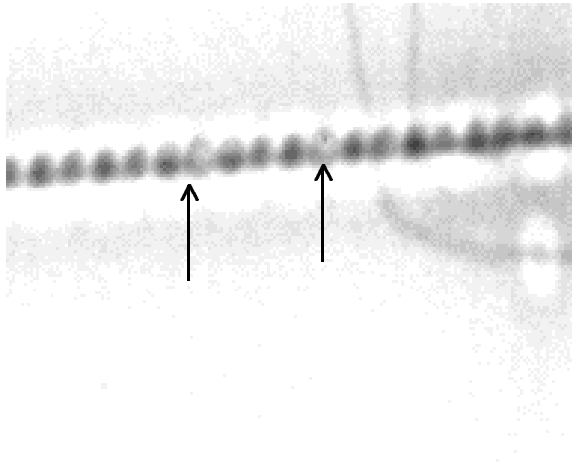
For the purposes of correlative analysis one of the thermally cycled parts was evaluated using micro focus x-ray (Figure 10). The x-ray results did not detect any cracks or delaminations but did show voids in some of the solder bumps. The voids could also be

Figure 10 - X-ray image of solder bumps. Two of the bumps appear brighter indicating the presence of voids. These two bumps correspond with the bumps shown in the acoustic image.

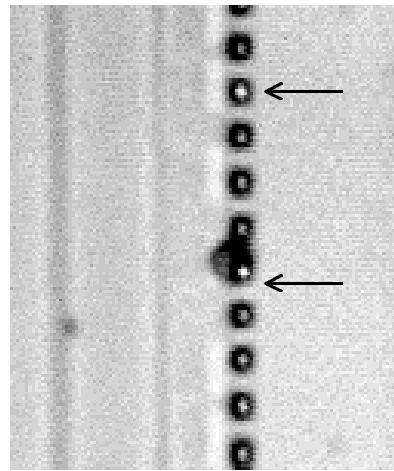
detected in the acoustic images of the device prior to thermal cycling. (Figure 11). After thermal stress the defects induced by the cycling obscured this level from ultrasonic inspection.

Figure 11 - Acoustic image of a row of solder bumps. Two of the bumps appear brighter in the center indicating the presence of voids in the solder bumps.

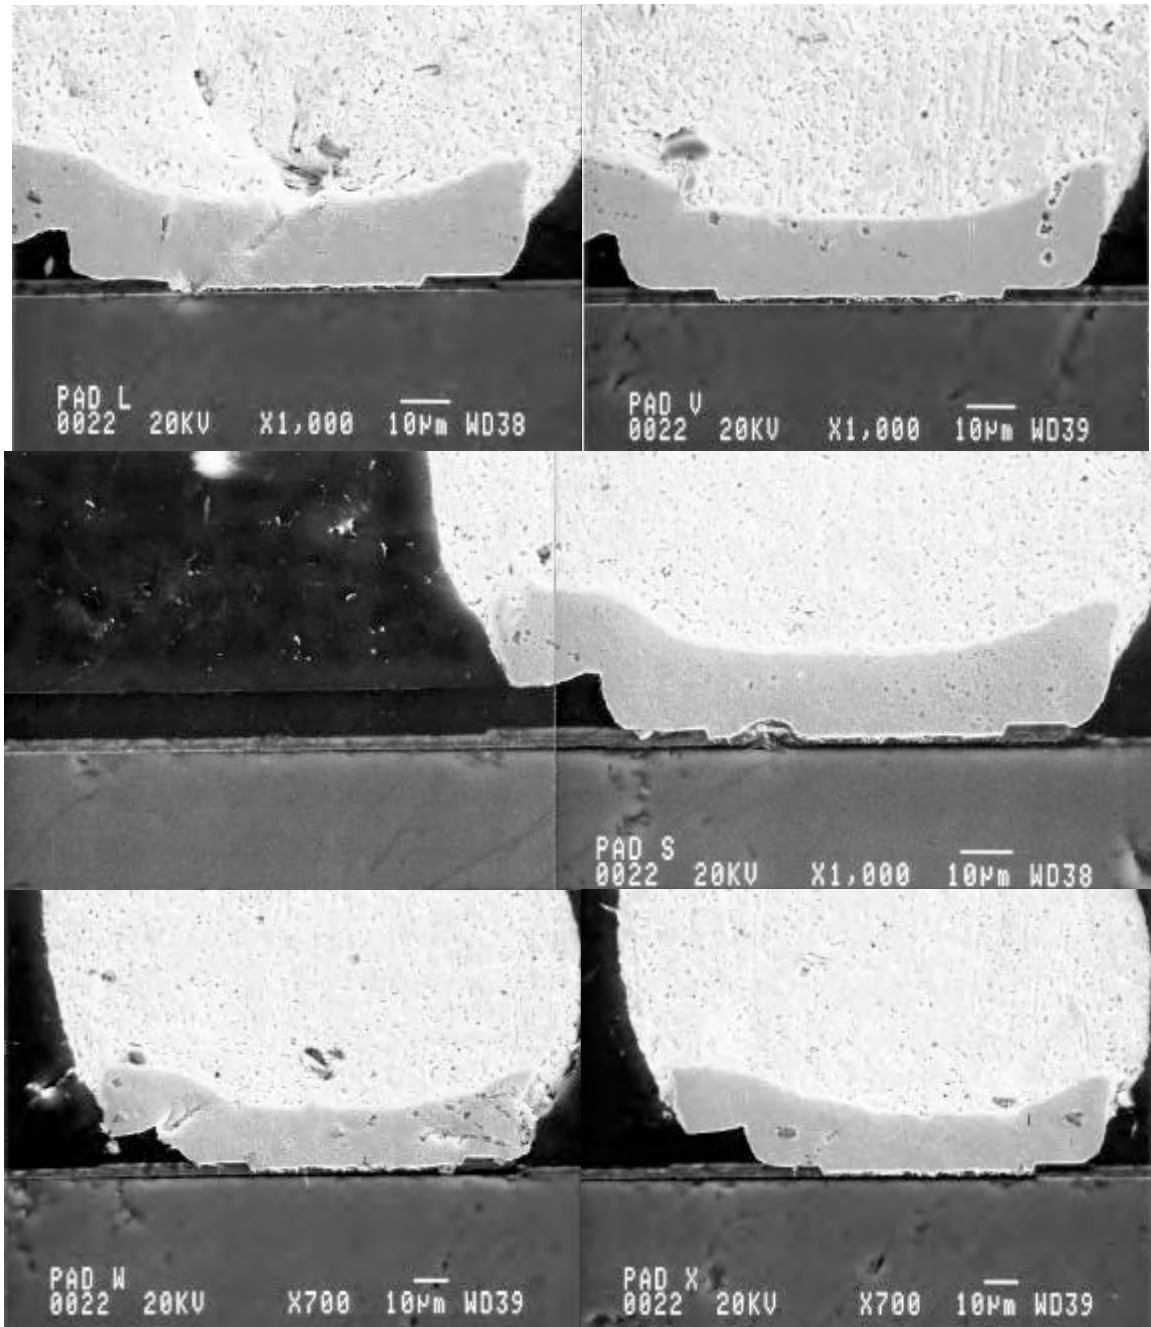
The part was then cross sectioned and this time Scanning Electron Microscopy was used to examine the section. The SEM evaluation did reveal the defects which caused the anomalies seen in the acoustic images. The defects were thin laminar cracks under the bond pads on the chip (Figure 12). In some cases the cracks extended out beyond the bump location under the glassivation layers. This is why some of the defects appeared larger than the expected size of the bond pads. A good correlation was now seen between

acoustic data and DPA results. In retrospect, the original cross sectioning had produced over rounding of the sample in the areas of interest and optical microscopy did not provide high enough resolution to image the thin cracks at the interfaces, but the optical microscopy did show bumps with large internal cracks upon which the attention was focused. This is why the other defects were not detected in the DPA initially and why the results of the DPA and acoustic analysis did not appear to show correlation at first.

Figure 12 - SEM micrographs of DPA cross sections of several bumps shown in Figure 8. Site L and V appeared dark in the acoustic image indicating bond at this level. The DPA section shows no defects in the bond of the bond pad to the silicon or glassivation layers. Sites S, W and X display a laminar crack under the bond pad. The cracks extend under the surrounding glassivation layers. These bumps appeared bright indicating defects in the acoustic image.

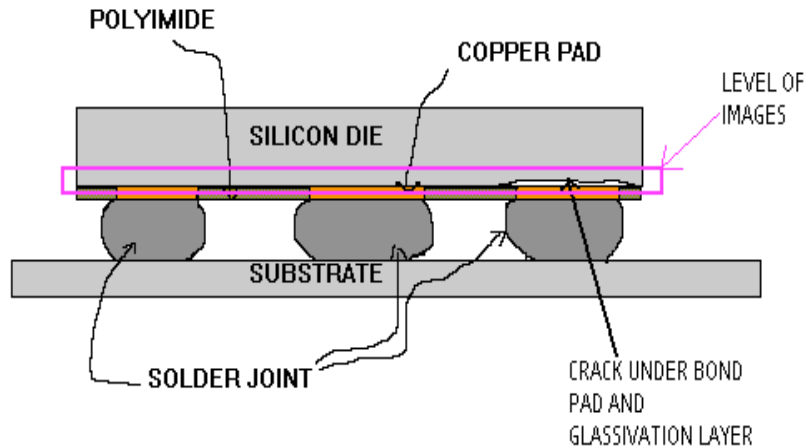
Figure 13 - Diagram of device showing level of the defects detected in the acoustic images.
