Characterization of Flip Chip Interconnect Failure Modes Using High Frequency Acoustic Micro Imaging With Correlative Analysis

Janet E. Semmens and Lawrence W. Kessler
SONOSCAN, INC.
530 East Green Street
Bensenville, IL 60106 U.S.A.
Tel: 630 766-7088 Fax: 630 766-4603

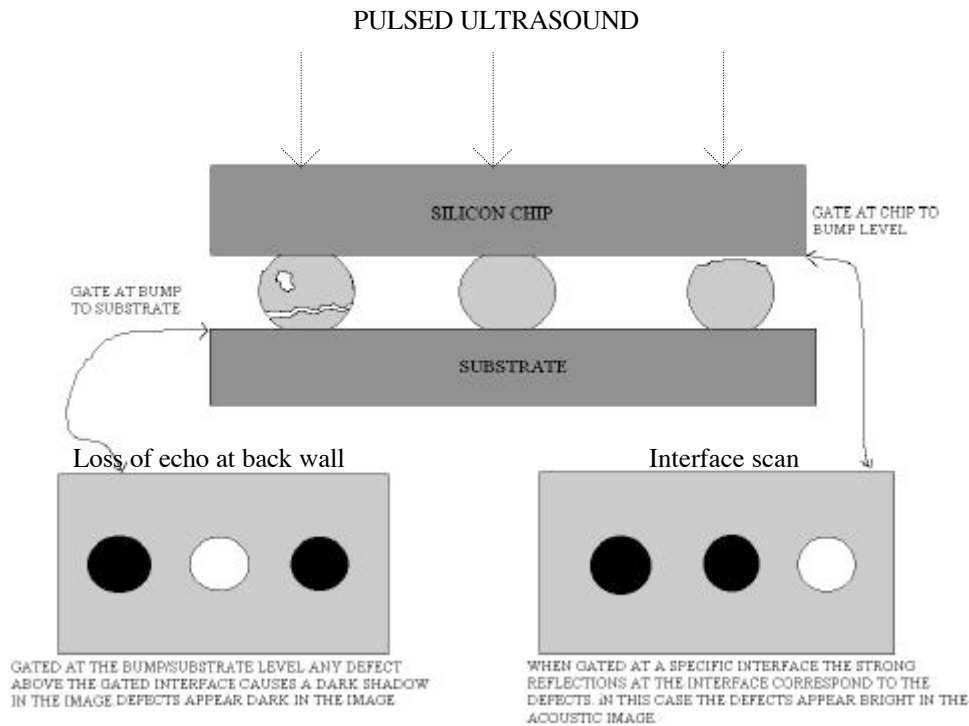
Figure 1 - Loss of echo at back surface versus interface scan. The loss of back surface echo technique will pick up defects at all levels within the interconnect but does not specify the level of the defect. The interface scan is level specific. However, defects occurring at layers below the gated region are not detected.

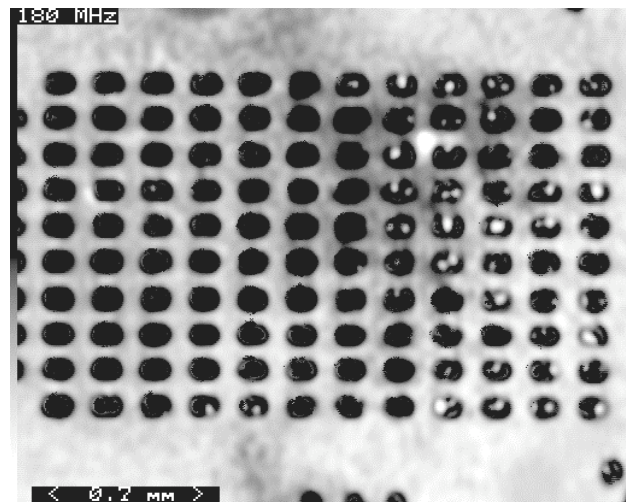
Figure 2 - 180 MHz acoustic image of flip chip bonds. Small voids at the interface appear as white features. Bonded bumps appear dark. A void (white area) is also present in the epoxy underfill

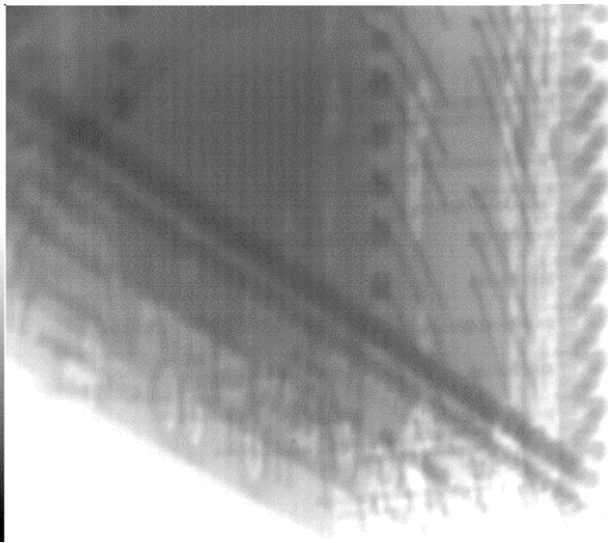
Figure 3 - X-ray image showing the complex multilayer construction of the ceramic substrate.

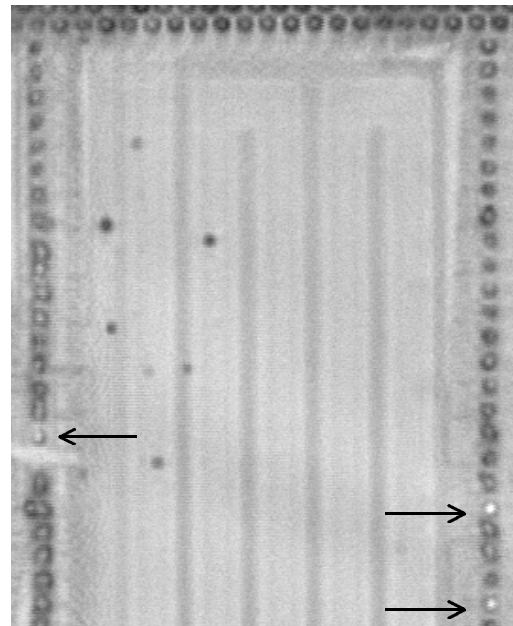
Figure 4 - 100 MHz Acoustic image of the bump to substrate level through the chip side of the sample. In this image the entire volume of the bump is interrogated. There is a contrast reversal using this imaging method which causes the bonded bumps to appear bright. Bright areas indicate where the sound transmits through the entire thickness of the bump unobstructed. Defects at the chip/bump level or within the solder bumps above the substrate interface block the signal from the interface so the defective bumps appear dark.

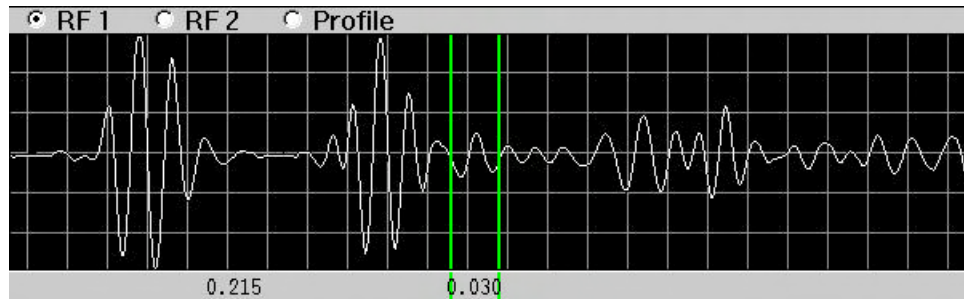
A-Scan in area of defective solder bump.

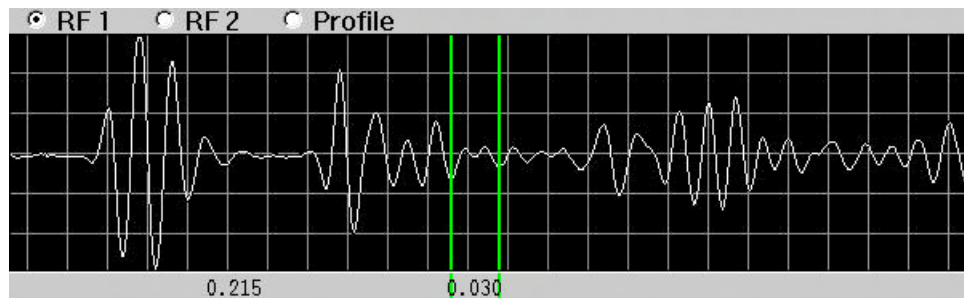
Figure 5 - Example of 100 MHz A-Scans using the loss of back wall echo method. At this level the bond sites which do not contain defects show a signal within the gate and the bonds containing delaminations, voids and cracks show no signal in the gate.

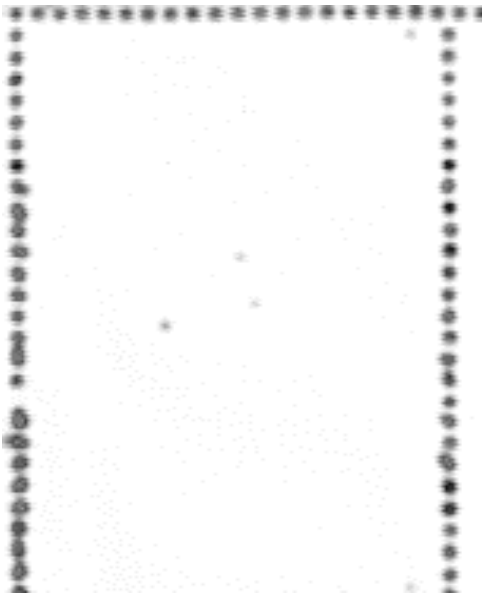
Figure 6 - Acoustic image including all levels between the silicon and the solder bump. The bond sites show low reflection levels which would typically indicate bonding at the interface. However, some of the sites appear larger than the nominal size of the bonds and irregular in shape

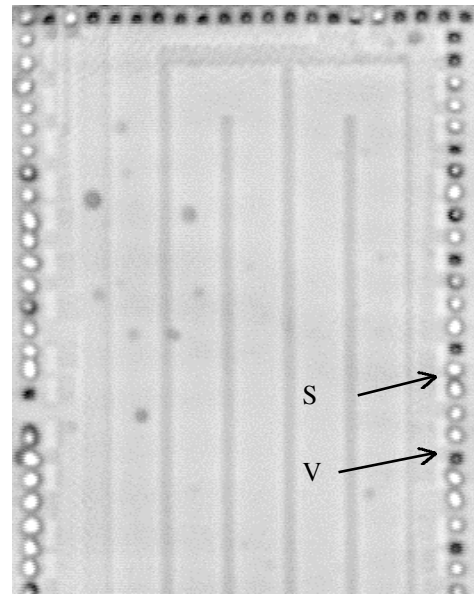
Figure 7 - Acoustic image of chip/bond pad level using level specific imaging technique. Now variations in the signal intensity are apparent from one bond site to another. In contrast to Figure 6 the parameters for this image cause the strong signal reflections characteristic of voids and delaminations to be shown in white. The white bumps also are the ones which display the larger, irregular shapes. Dark spots (low signal reflections) indicate the bonded pads at this level. Several of the sites are indicated by the arrows for reference in the corresponding DPA images.

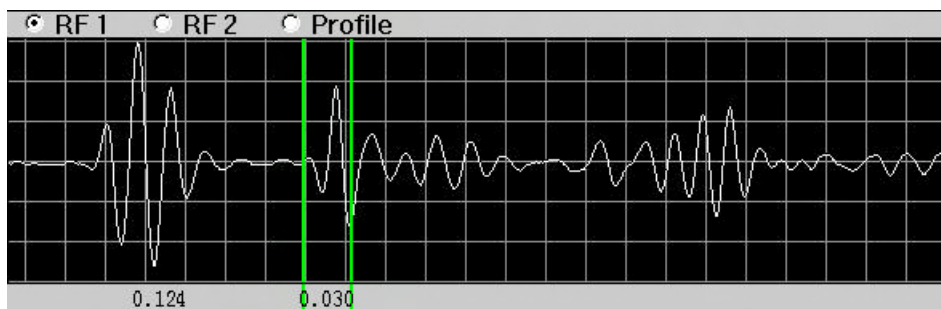
A-Scan corresponding to bonded pad.

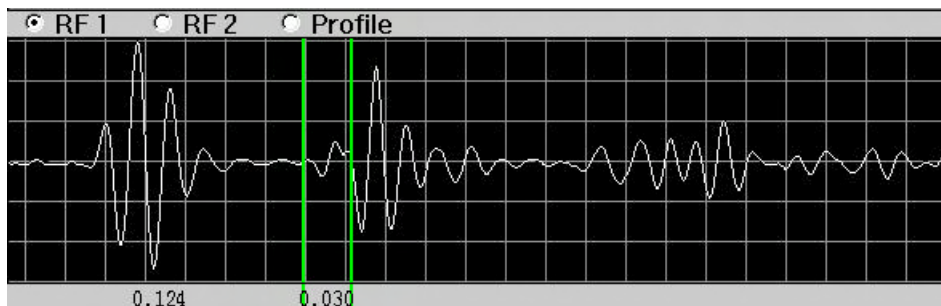
Figure 8 - A-Scans showing the location of the gate (designated by the 2 vertical lines over the trace) to obtain the images of the bond pad and glassivation separations from the silicon. The echoes corresponding to the defects show a significantly higher amplitude than the echoes corresponding to the bonded pads.

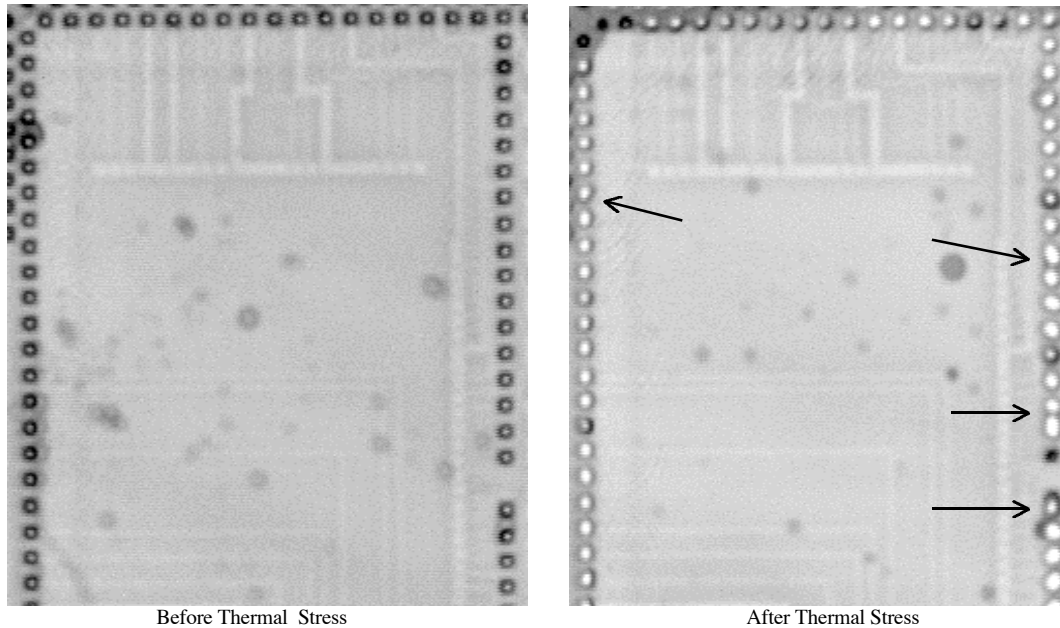
Figure 9 - Acoustic images of the same device before and after thermal stress. The bond sites appear as dark circles, uniform in size before stress. After stress most of the bond sites now appear bright white and some are considerably larger in size and irregularly shaped. Examples are indicated by arrows.

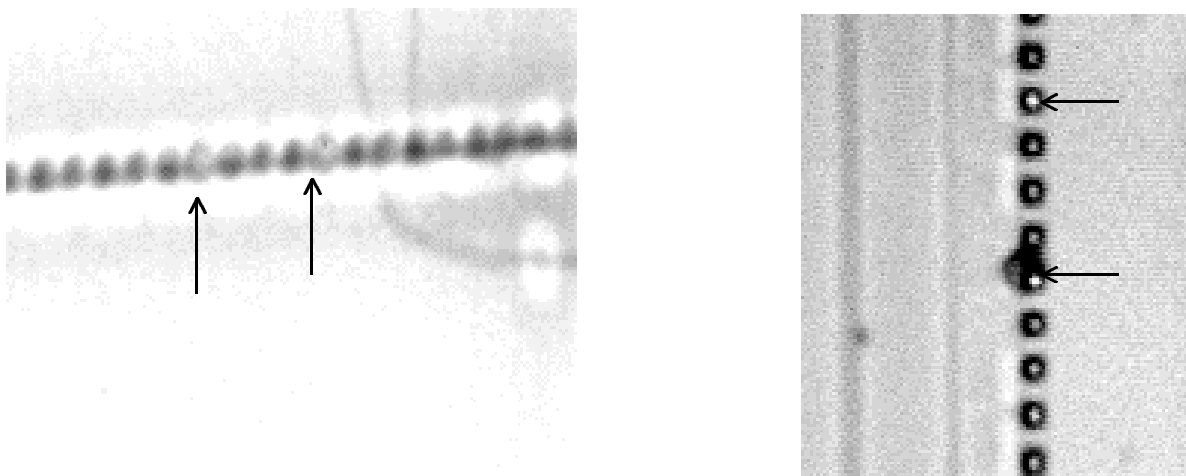
Figure 10 - X-ray image of solder bumps. Two of the bumps appear brighter indicating the presence of voids.

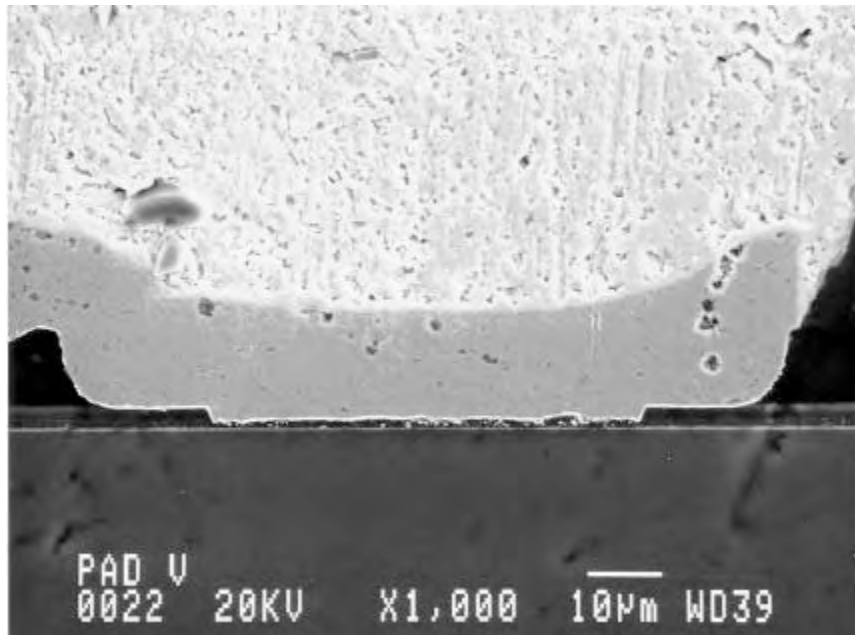
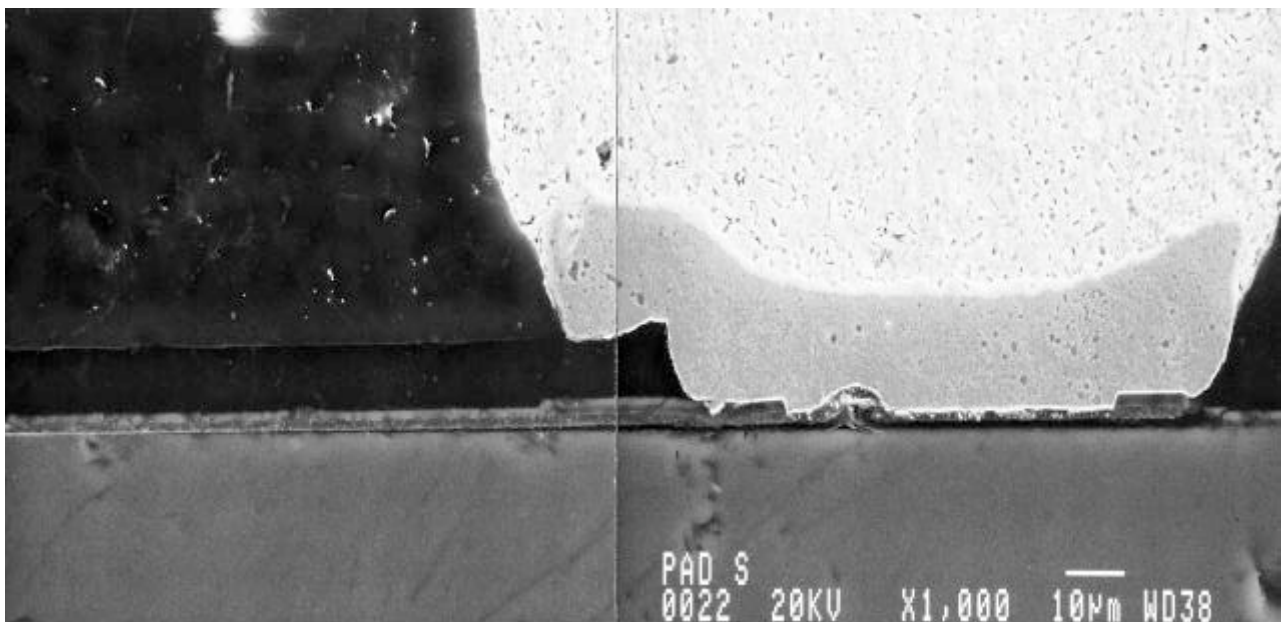
Figure 12 - SEM micrographs of DPA cross sections of bumps V and S shown in Figure 8. Site V appeared dark in the acoustic image indicating bond at this level. The DPA section shows no defects in the bond of the bond pad to the silicon or
