# Acoustic Detection of Package Contamination

Able to image the interface between the package and die, acoustic imaging detects defects, contamination and molding compound issues.

**Tom Adams and Ray Thomas,**  
Sonoscan Inc.,  
Elk Grove Village, Ill.,  
[www.sonoscan.com](http://www.sonoscan.com)

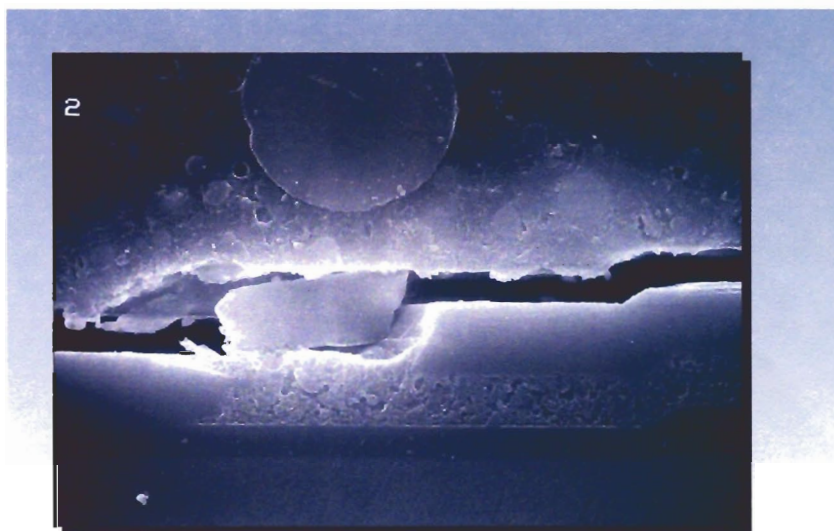
**1.** SEM of a sectioned sample showing the delamination between the particle-filled molding compound (top) and the die face (bottom). (Source: Riga Analytical Lab Inc.)

One delaminated sample was cross-sectioned through the center and lightly etched for SEM imaging (Fig. 1). Imaging showed that the delamination between the molding compound and die face was as little as 0.6  $\mu\text{m}$  thick. Gas-filled delaminations and other gaps down to 0.01  $\mu\text{m}$  uniformly reflect virtually all of an ultrasonic pulse, so the thickness of this delamination was not significant.

The cross-section did not reveal the presence of a contaminant, because the contaminant was most likely removed during preparation of the sample.

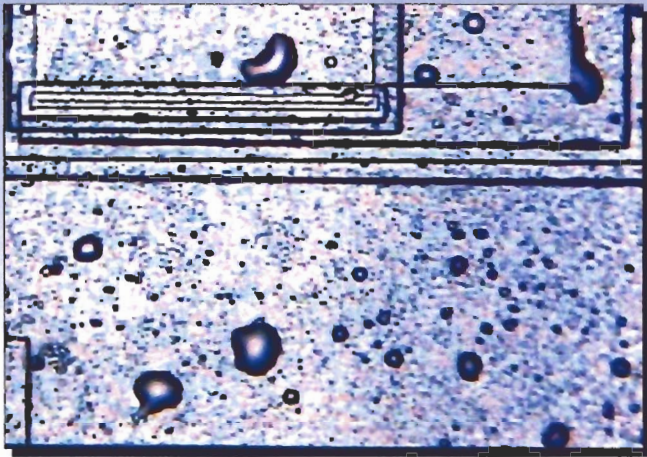
**2. Microdroplets were found on the inner surface of the molding compound after dry separation.** (Source: Riga Analytical Lab Inc.)

Another delaminated package was disassembled by a dry separation technique to give access to the die surface and inner surface of the molding compound. An examination of the inner surface of the removed molding compound revealed micro-droplets of a colorless fluid (Fig. 2). Because

there was no evaporation of this fluid after some hours of exposure at room temperature, it was concluded that this fluid was not water alone. The plastic surface was then examined by energy dispersive X-ray (EDX) analysis. In the vacuum chamber, the fluid evaporated and phosphorus was detected on the surface of the plastic. Since phosphorus

is hygroscopic, its presence may have prevented the water from initially evaporating. The source of the phosphorus is unknown, as it is rarely used in molding compounds.

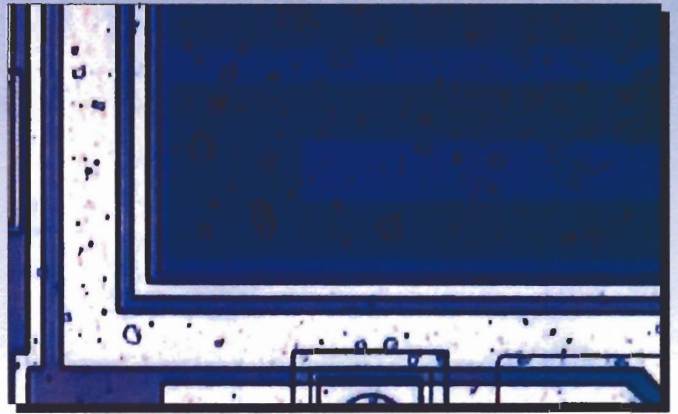
**3. Surface of the die after dry decapping. Small irregular areas are the residue of a contaminant. Auger electron spectroscopy showed the presence of silicon, carbon and oxygen, suggesting that the contaminant may have been a silicone.** (Source: Riga Analytical Lab Inc.)

The die face was examined next (Fig. 3) by Auger electron spectroscopy (AES). A dry residue was noticed on the die face.

The AES surface analysis of the residue on a bond pad was carried out first without treatment, and then after ablative sputtering with argon ions to remove 20 and 50 Å of material. Comparison with a similarly evaluated control sample showed that carbon, oxygen and silicon were all present in greater concentrations than in the control sample. Identification of the residue as an organic compound suggested that the fluid contaminant in the delamination may have been any of various types of silicone, whose molecules consist of SiO and an organic radical. A silicone is used as a releasing agent in the molding process to facilitate ejection of the parts. The possibility exists that silicone from this source is making its way onto the die face before encapsulation. Bromine was also present in the EDX analysis, because it had most likely leached out of the molding compound.

This analysis does not prove conclusively that the contaminant is silicone, or that its source is the releasing agent, but it does provide an answer that fits very well with the acoustic data. The acoustic pulse used in imaging encounters, in order, the plastic molding compound, which has a

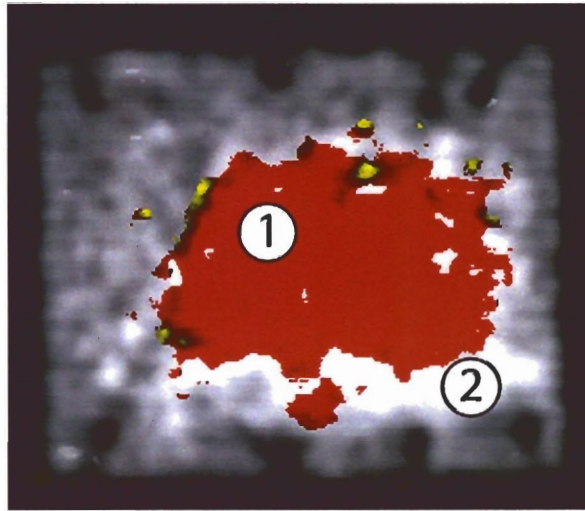
**4.** Acoustic image made at the depth of the top surface of the die. Red area (1) is an air-filled delamination that stops further penetration of ultrasound and gives a high-amplitude negative echo. The white area (2) that partly surrounds the delamination results from a distorted echo created by a thin layer of fluid contaminant.

Figure 4 shows a red/white delamination image. In the center of the delamination, the ultrasound encountered an air gap adjacent to the molding compound, resulting in a negative echo. The ultrasound does not proceed any deeper because it is totally reflected at this interface. In the white area adjacent to the red area, the ultrasound encountered a very thin fluid contaminant layer that separates the encapsulant and die. This layer produced a distorted echo whose attributes are not clearly positive or negative, and in these cases, the algorithm displays these echoes as white.
