Acoustic Micro

Tom Adams,
Consultant,
Sonoscan Inc., Elk
Grove Village, Ill.,
www.sonoscan.com

Imaging of Stacked Die

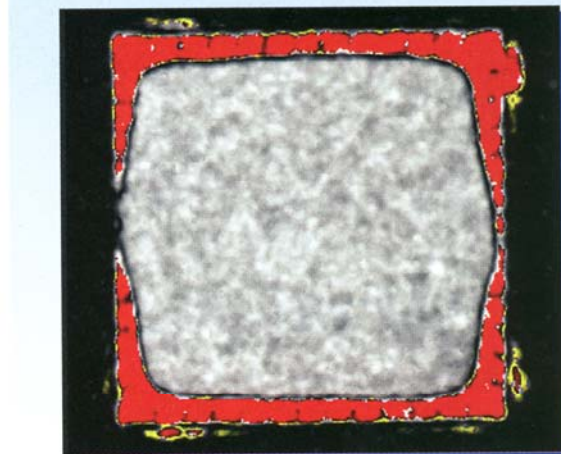
1. A two-die plastic package, imaged from the top side at the interface between the molding compound and the top of the first die (left). The red area marks the delamination of the molding compound, critical because the delaminated area encompasses the wire bonds.

A few of the types of internal anomalies that may be found in stacked-die configurations are described and illustrated in this article. Figures 1 and 2 were made from a stack of two die encapsulated in a plastic molding compound. Figure 1 was gated at the top-die top surface at the interface with the molding compound above the die.

The red area around the periphery of the die surface is a die-face delamination, where the molding compound is not bonded to the die. The color red indicates a very high-amplitude returned echo signal from this gap-type defect. Research at Sonoscan has recently shown that reflection from gaps is nearly 100%, even if the thickness of the gap is as little as 100-1000 Å.

This delamination includes the wire bonds on the surface of the chip, and poses two long-term threats to reliability. First, relative motion of the chip and the molding compound (caused, for example, by thermal cycling) may break wire bonds. Second, the delamination is likely to become a collection point for moisture and contaminants that can corrode the wire bonds.

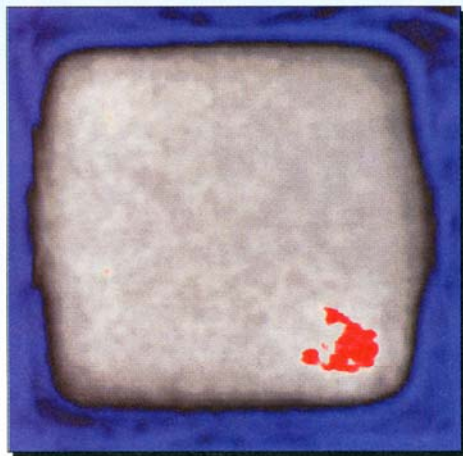
2. The same two-die stack (left), imaged at the die attach level below the first die — note that the delamination above this level crops the imaging of the die attach. The small red area is a gap-type defect.

Figure 2 is the acoustic image of the die attach beneath this die. In this acoustic image, the die attach has a somewhat irregular shape because of the blocking of ultrasound by the delamination at the die surface above this depth, as shown in Figure 1. Most of the visible die attach region appears gray and homogeneous — that is, without defects. A small region at lower right is red, indicating some form of gap-type defect.

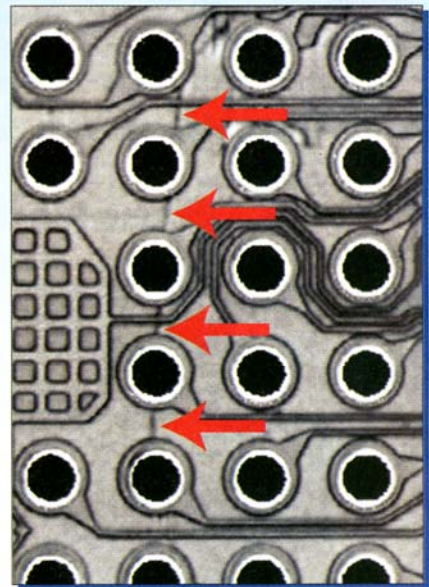
3. A different two-die package (right), imaged acoustically from the bottom side. The arrows mark a crack in the lower die.

Figure 3 is the acoustic image of the bottom side of a different two-die stack, also encapsulated as a plastic package. This package was imaged before surface mounting, and could therefore be accessed from either the top or bottom surface. Figure 3 was made from the bottom side and shows, in addition to the traces

on the interposer, a crack (arrows) in the lower of the two die.

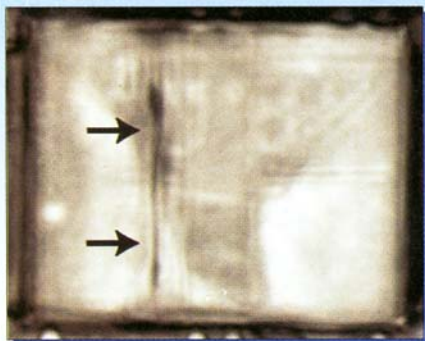
4. The same package as in Figure 3, imaged acoustically from the top surface. Pulsed through four intervening interfaces, C-SAM ultrasound was able to image the die crack shown here from the top of the package.

Next, the package was flipped over and imaged from the top side. Imaging at various depths showed that there were no defects relating to the top die. Gating was then set at below the top of the second die, in the bulk of the silicon, in order to image the same die crack from the top surface of the package. In order to image the crack, ultrasound had to be pulsed through four interfaces above the crack: the top surface of the package, the interface between the overlying molding compound and the top of the first die, the interface between the bottom of the first die and the adhesive layer, and the interface between the adhesive layer and the top of the second die. Figure 4 shows the result of this deep image. The crack is indicated by the arrows.
