# CHARACTERIZATION OF FLIP CHIP BUMP FAILURE MODES USING HIGH FREQUENCY ACOUSTIC MICRO IMAGING

Janet E. Semmens and Lawrence W. Kessler  
SONOSCAN, INC.  
530 East Green Street  
Bensenville, IL 60106 U.S.A.  
Tel: 630 766-7088 Fax: 630 766-4603  
E-mail: sonoscan@WorldNet.att.net

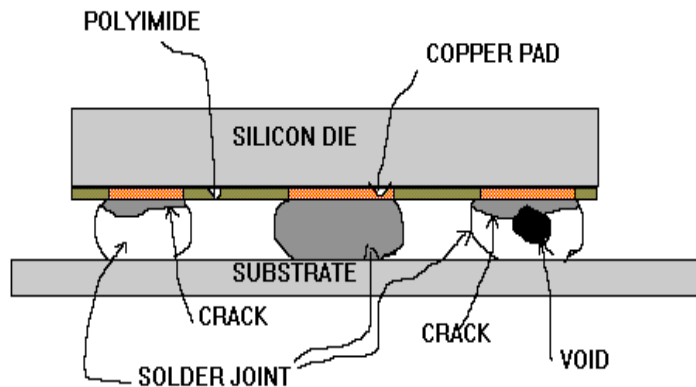
The devices used in this study demonstrated electrical failures after thermal cycling. The samples were examined with microfocus x-ray. Voids detected in the solder joints after thermal cycling were also present prior to cycling. Subsequent destructive physical analysis using standard optical microscopy revealed the presence of cracks in the solder joints which were thought to be the primary failure mode (Figure 4).

Figure 4 - The above diagram shows the general construction of the device and the expected failure mode, cracks in the solder bumps.
